HYDRO-AIRE
A SUBSIDIARY OF CRANE CO.

SERVICE BULLETIN

Bulletin No. 60-703-28-33
Revision 2, 2003/02/17
H/A 8-160 & 8-272
ATA 28-31

FUEL – MODIFICATION OF FUEL OVERRIDE JETTISON PUMP HOUSING SUBASSEMBLIES PART NO. 60-703200, 60-70304, 60-70305, 60-72314, 60-703135 (BPN 60B92603-21, -2, -5, -19, -20), TO PART NO. 60-703200-1, 60-70304-1, 60-70305-1, 60-72314-1, 60-703135-1 (BPN 60B92603-25, -102, -105, -119, -120), USED ON 747 / 747-400 AIRCRAFT.

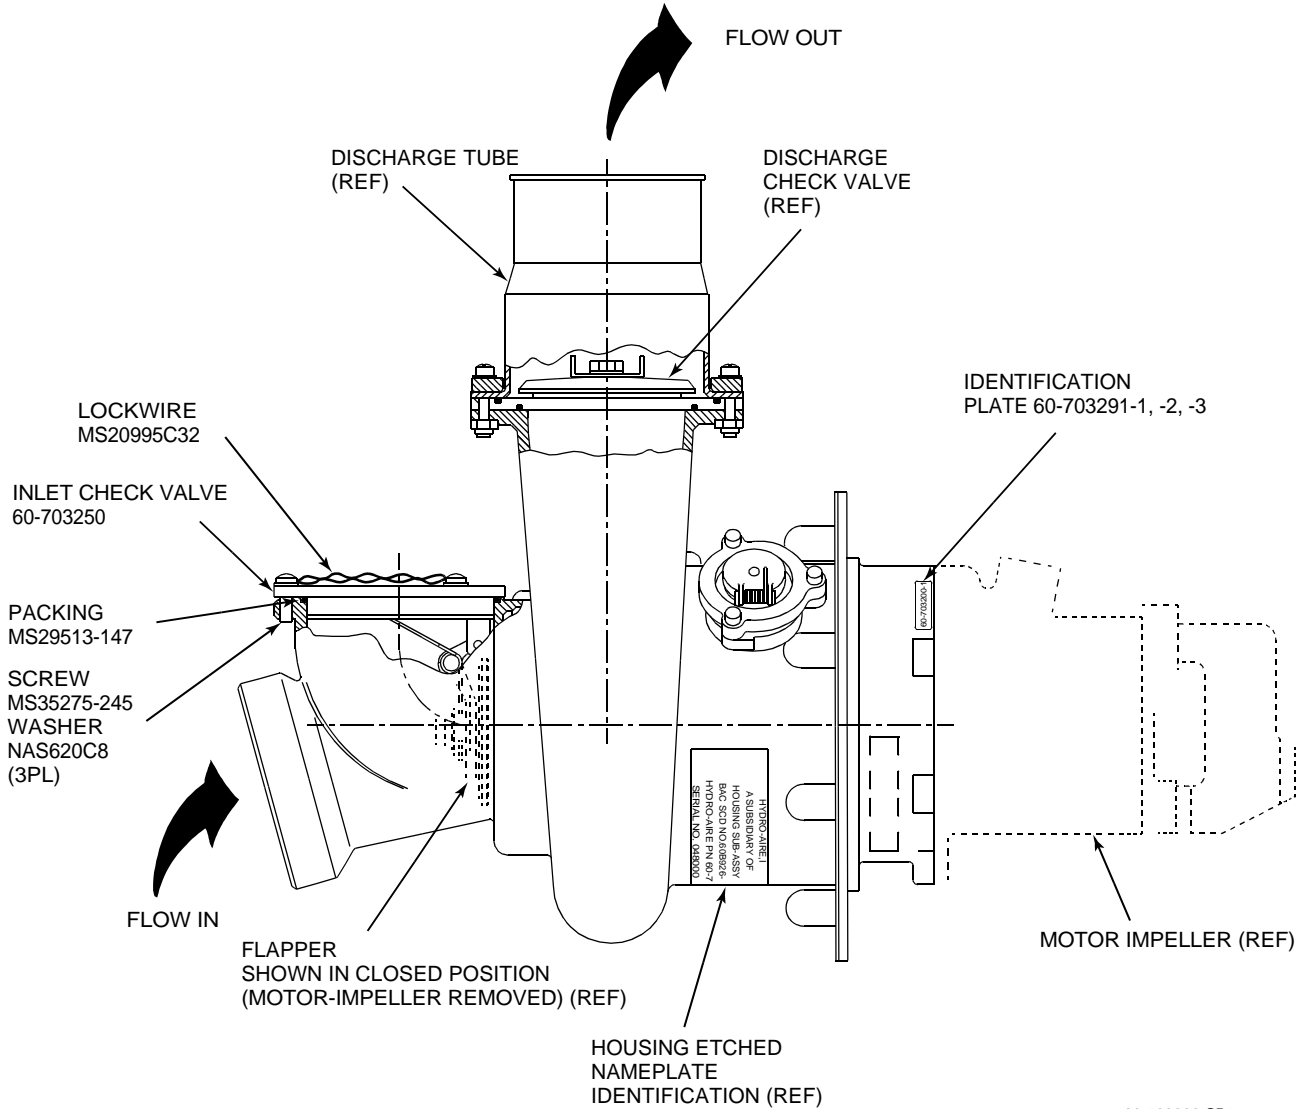
**Typical Pump Housing
Figure 1**

Excessive wear of the inlet check valve against the override/jettison pump inlet adapter has been reported. Vibration of the inlet check valve in the fuel stream can cause flapper deterioration, allowing pieces of the inlet check valve to be ingested into the pump's inducer/impeller. Wear to the motor impeller subassembly inlet adaptor also occurs at the point of contact with the inlet check valve.

This service bulletin gives instructions for the modification of Hydro-Aire Fuel Override/Jettison Pump Housing Subassemblies shown in paragraph 1.A. The resulting -1 configurations will include a new inlet check valve, P/N 60-703250, and identification plate, P/N 60-703291-1, -2, or -3 (see Figure 1).

- (1) Refer to the DISASSEMBLY section in the applicable reference shown in paragraph 1.J. and remove the P/N 60-703137 inlet check valve and P/N MS29513-147 packing from the fuel jettison pump assembly housing P/Ns 60-703200, 60-72314, 60-70304, 60-70305, or 60-703135.
- (2) Install new P/N MS29513-147 packing as shown on the new P/N 60-703250 inlet check valve assembly (see Figure 2 below).
- (3) Use three P/N MS35275-245 screws and P/N NAS620C8 washers to attach the new P/N 60-703250 inlet check valve assembly to the P/Ns 60-703200, 60-72314, 60-70304, 60-70305, or 60-703135 pump housing.
- (4) Torque P/N MS35275-245 screws to 11–13 in.-lb (1.24–1.47 Nm) and safety wire screws with P/N MS20995C32 or MS20995C20 lockwire as directed in MS33540 (see Figure 1).

- (5) Install the identification plate on the housing in the location shown in Figure 1.
- (6) Clean off excess adhesive and allow adhesive to cure as specified in BAC 5010, Rev. W, paragraph 8.2.40.
