SERVICE BULLETIN

B747

Bulletin No. 60-703-28-35
Revision 3, 2004/02/03
H/A 8-160
ATA 28-31

FUEL – MODIFICATION OF FUEL OVERRIDE JETTISON PUMP MOTOR-IMPELLER SUBASSEMBLIES P/N 60-70303, 60-70306, 60-70307, 60-70308, 60-70309, 60-703103, 60-703104, 60-703113, (BPN 60B92603-3, -7, -9, -10, -11, -13, -14, -15) TO P/N 60-70303-3, 60-70306-3, 60-70307-3, 60-70308-3, 60-70309-3, 60-703103-3, 60-703104, 60-703113-3 (BPN 60B92603-303, -307, -309, -310, -311, -313, -314, -315).

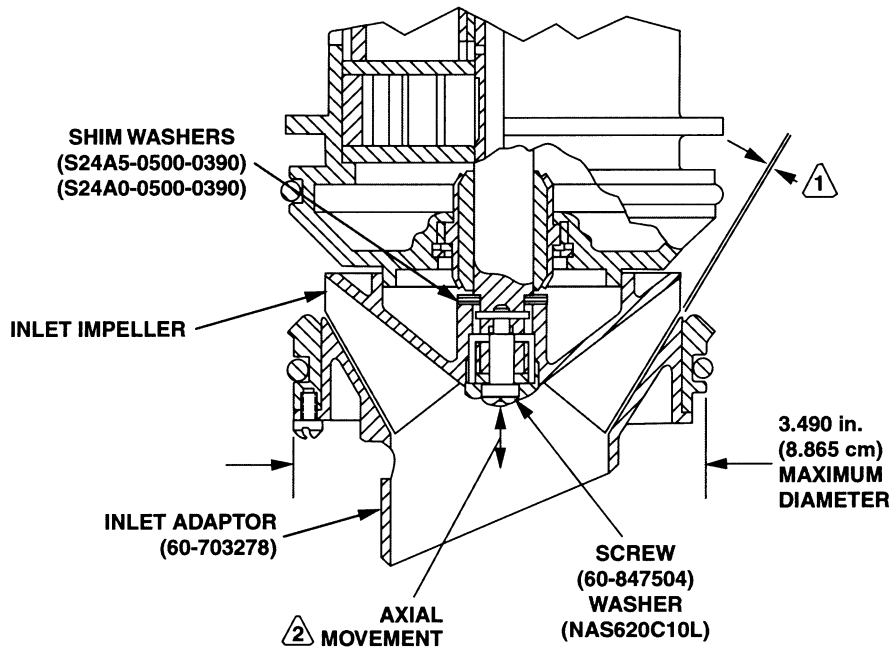
**Inlet Impeller-to-Inlet Adaptor Clearance
Figure 1**

① 0.007 – 0.010 in (0.018 – 0.025 cm) CLEARANCE.

② 0.001 – 0.008 in (0.003 – 0.020 cm) AXIAL MOVEMENT BEFORE AND AFTER TEST.

NOTE: Be sure that safety wire does not extend beyond the 3.490-inch (8.865-cm) maximum diameter, as shown in Figure 1.

NOTE: Clearance between the inlet impeller and inlet adapter must be 0.007 to 0.010 inch (0.018–0.025 cm). Add or remove shim washers, S24A5-0500-0390 or S24A0-0500-0390, to get the required clearance. The ratio of clearance to washers is 1:2. That is, a 0.001-inch difference in clearance requires a 0.002-inch change in shim washers.
