REVISION NO. 3, DATED 2004/02/03

B747

Bulletin No. 60-723-28-5
Revision 3, 2004/02/03
H/A 8-272-3
ATA 28-31

**FUEL OVERRIDE/JETTISON PUMP: MODIFICATION OF MOTOR-IMPELLER SUBASSEMBLY
P/N 60-72301 (BPN 60B92603-18) TO P/N 60-72301-3
(BPN 60B92603-318)**

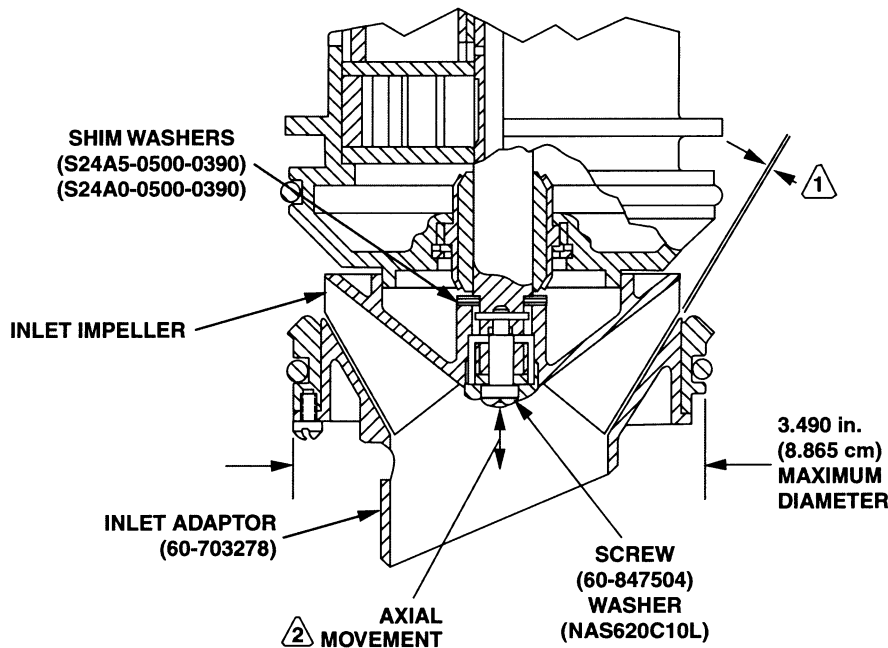
Inlet Impeller-to-Inlet Adaptor Clearance
Figure 1

NOTE: Clearance between the inlet impeller and inlet adapter must be 0.007 to 0.010 inch (0.018–0.025 cm). Add or remove shim washers, S24A5-0500-0390 or S24A0-0500-0390, to get the required clearance. The ratio of clearance to washers is 1:2. That is, a 0.001-inch difference in clearance requires a 0.002-inch change in shim washers.

1 0.007 – 0.010 in (0.018 – 0.025 cm) CLEARANCE.

2 0.001 – 0.008 in (0.003 – 0.020 cm) AXIAL MOVEMENT BEFORE AND AFTER TEST.

NOTE: Be sure that safety wire does not extend beyond the 3.490-inch (8.865-cm) maximum diameter, as shown in Figure 1.

- (F) Measure the clearance between the inlet impeller and inlet adapter by inserting a feeler gauge with a width of 0.200 inch (05.08 cm) or less and a thickness of 0.007–0.010 inch (0.018–0.025 cm) between the two parts.

- (G) Remeasure the inlet-impeller-to-inlet adapter clearance to be sure that it is within range, repeating the steps of paragraph (F) until clearance is correct.
