SERVICE BULLETIN

BOEING DC-10 (SERIES 10, 30, AND 40), KC-10A, DC-10-30F (KDC-10),
MD-10 (SERIES 10 AND 30), AND MD-11

Bulletin No. 60-847-28-2
ATA 28-22

FUEL BOOSTER PUMP — PUMPING UNIT — INSPECTION TO DETECT IMPROPER FUEL PUMP INTERNAL LEAD WIRE ROUTING

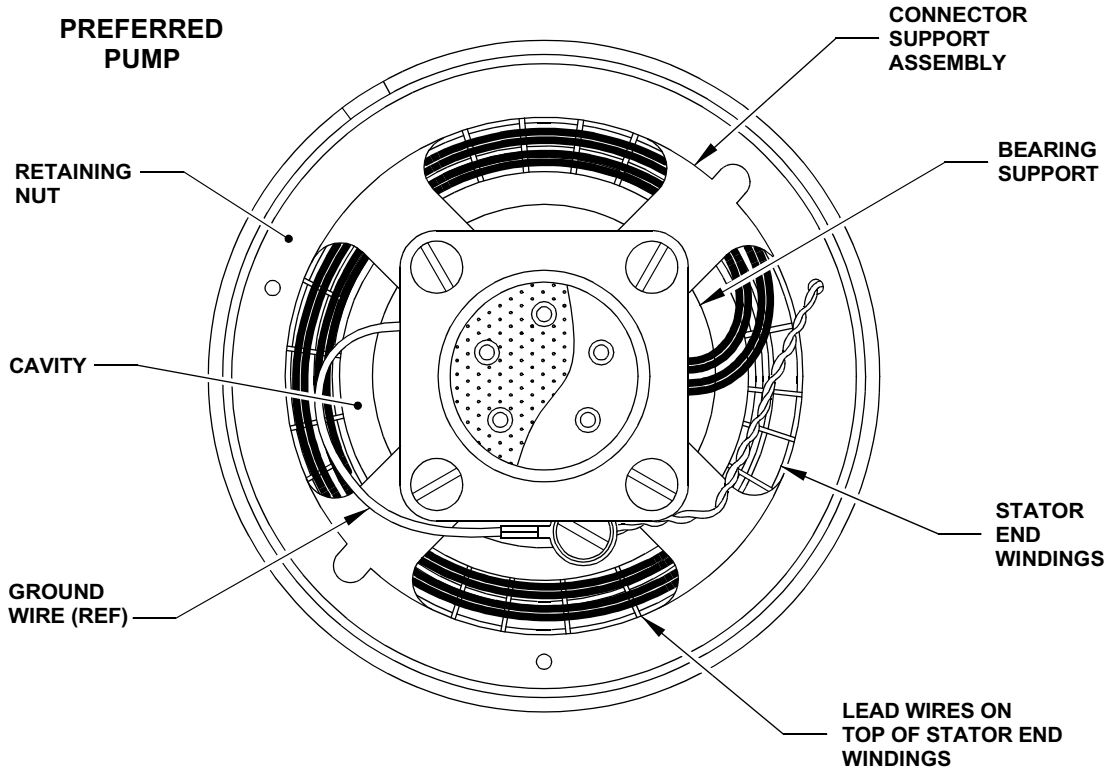
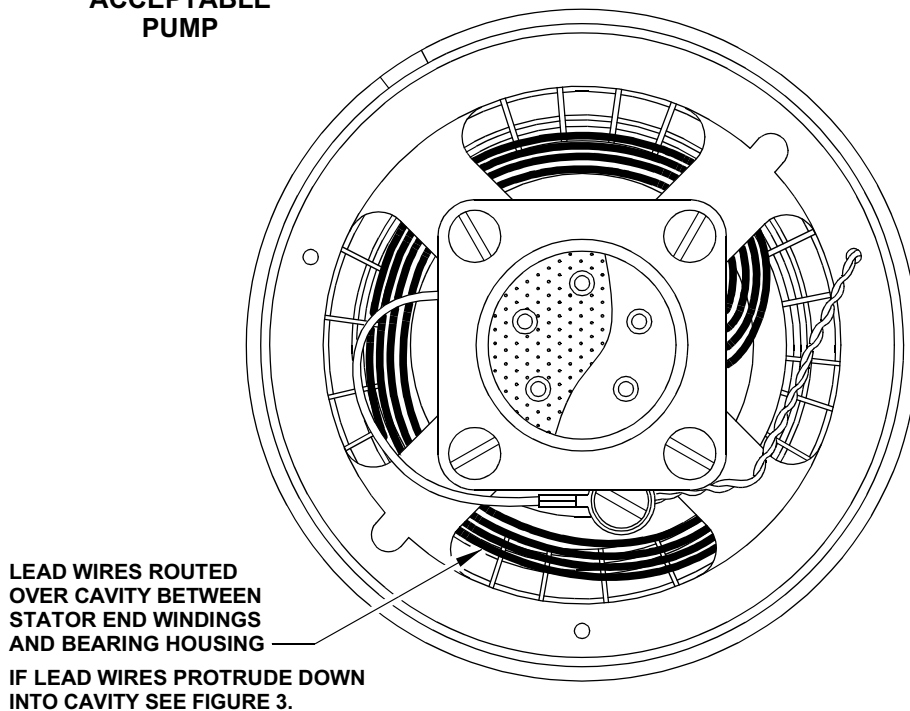
Acceptable Pumping Units
Figure 1

- (1) Visually check the stator lead wire routing through the four (4) slots in the connector support assembly as shown in Figure 1.
- (2) The preferred routing will have the lead wires coiled and resting on top of the stator windings (some wires may be obscured by the outer edge of the connector support) and not protruding down into the cavity between the bearing housing on the connector support assembly and the stator end windings (See Figure 1). Pumps with the lead wires in this condition are acceptable.

- (3) Pumps with a portion of the wires routed over the cavity and not protruding down into the cavity between the bearing housing on the connector support assembly and the stator end windings are acceptable (See Figure 1).

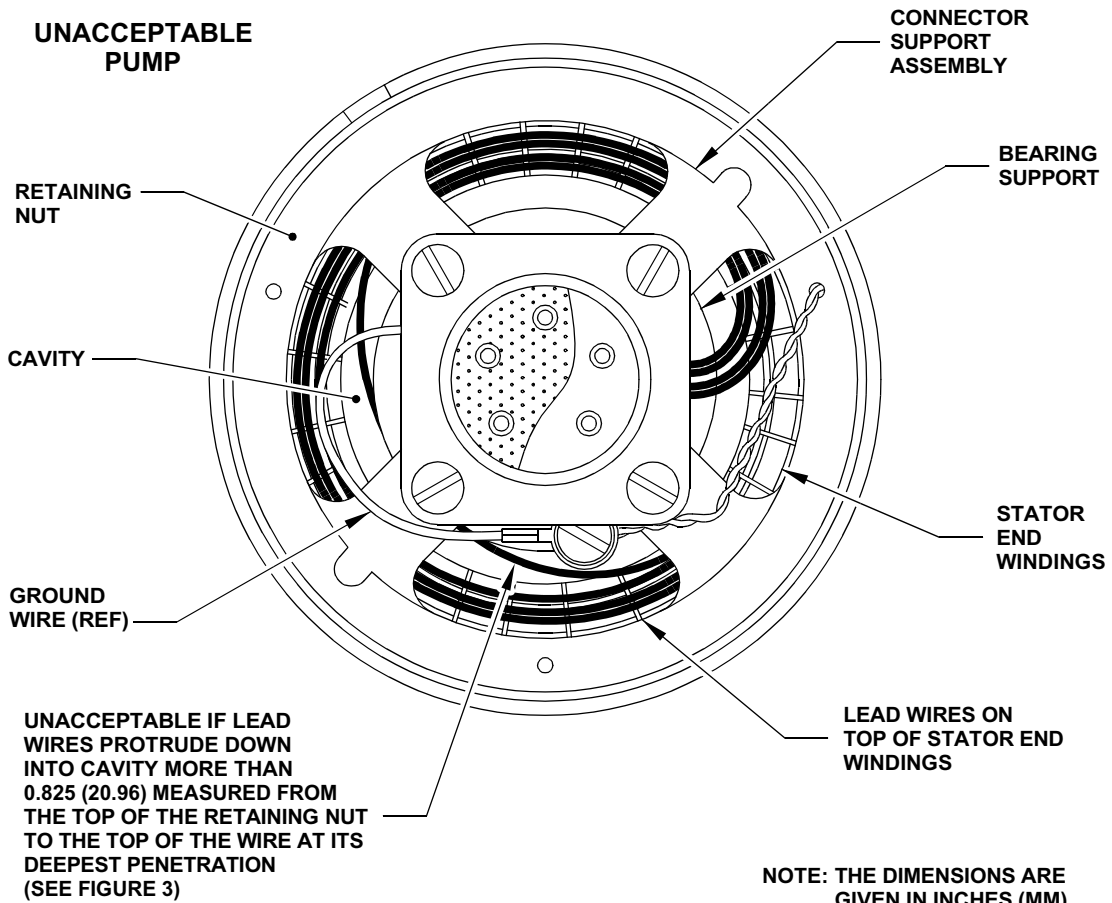
**Unacceptable Pumping Unit
 Figure 2**

- (4) On pumps with a wire or wires protruding down into the cavity (Figure 2), determine the extent to which the wire(s) protrude down into the cavity, as follows:

- (a) If there are multiple wires in the cavity, the lower-most one must be visible and accessible for inspection. Use a non-metallic, non-wooden tool (because of the possibility of splintering) to gently move the upper wires so the lowest wire is exposed. Use care not to damage the wire insulation. IF THE WIRES ARE ROUTED SUCH THAT THEY CANNOT BE MOVED TO ALLOW ACCESS TO THE LOWEST WIRE IN THE CAVITY, THE ASSEMBLY MUST BE REJECTED AND THE LEAD WIRE ROUTING CORRECTED.

- (6) If any lead wire protrudes down into the cavity below the limits allowed above or any damage is found, the pumping unit must be disassembled, repaired, and functionally tested in accordance with CMM 28-22-03. Removal and repositioning of the stator may be required to provide an adequate service loop for proper wire routing. The pump must be re-inspected in accordance with this Service Bulletin after repair.

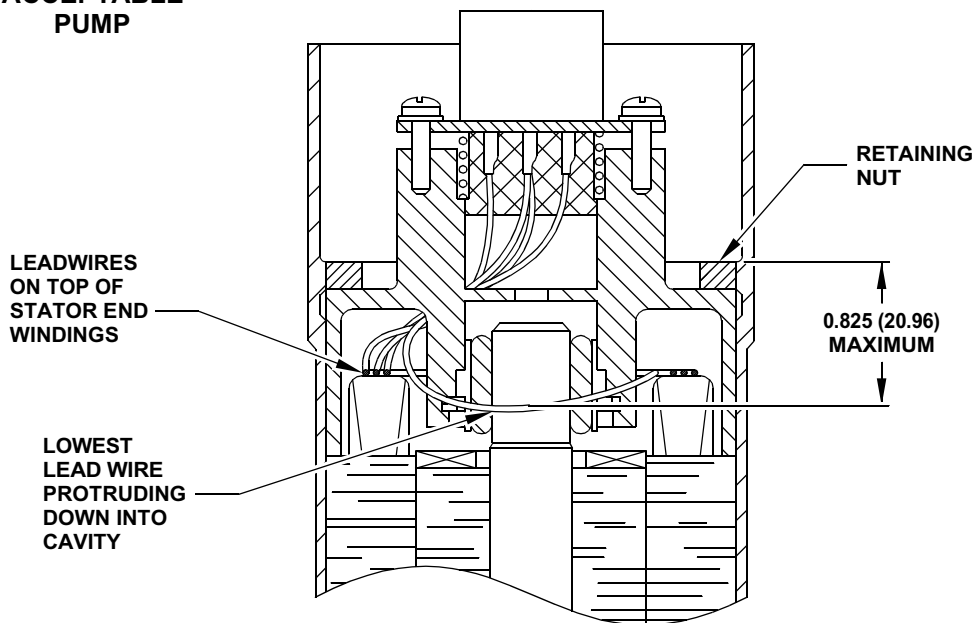
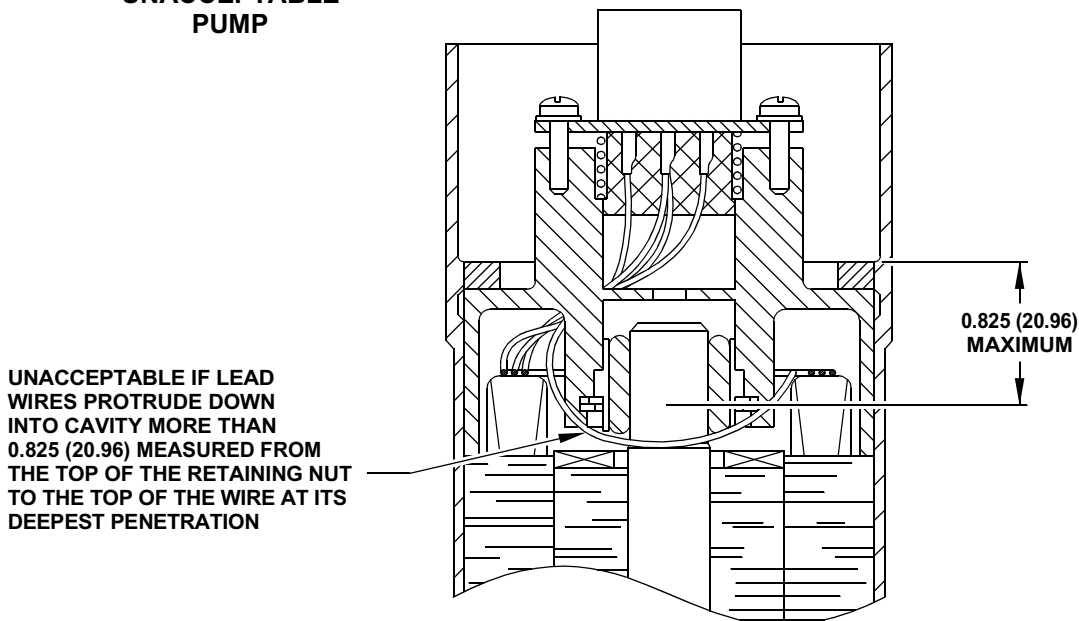
Measurement of Lead Wire Position
Figure 3

- (b) Carefully use a non-metallic, non-wooden measuring tool similar to that shown in Figure 4 to verify that the lowest portion of the loop on the lowest wire does not protrude down into the cavity between the bearing housing on the connector support assembly and the stator end windings more than 0.825 inch (20.96 mm) maximum when measured from the surface of the retaining nut down to the top of the lead wire (see Figure 3). Any lead wire that protrudes down into the cavity less than 0.825 inch (20.96 mm) is acceptable.

- (c) ANY LEADWIRE THAT PROTRUDES DOWN INTO THE CAVITY BETWEEN THE BEARING HOUSING ON THE CONNECTOR SUPPORT ASSEMBLY AND THE STATOR END WINDINGS MORE THAN 0.825 INCH (20.96 MM) WHEN MEASURED FROM THE SURFACE OF THE RETAINING NUT DOWN TO THE TOP OF THE LEADWIRE IS UNACCEPTABLE AND MUST BE REJECTED AND THE LEAD WIRE ROUTING CORRECTED.

- (d) IF THE LOWEST POINT OF THE WIRE PROTRUDING DOWN INTO THE CAVITY CANNOT BE MEASURED, THE PUMP MUST BE REJECTED AND THE LEAD WIRE ROUTING CORRECTED.

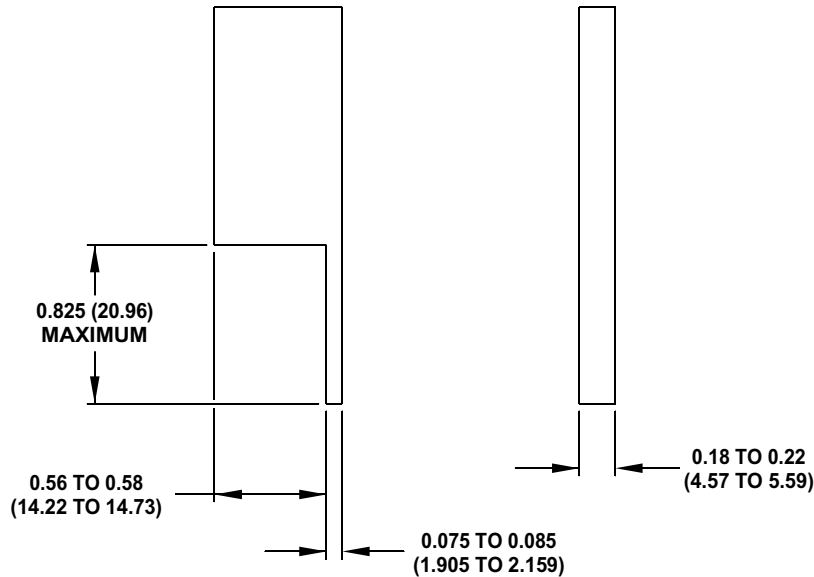
**Measurement Tool
Figure 4**

- ① ROUND OFF CORNERS AND SHARP EDGES.
- ② MANUFACTURE FROM NON-METALLIC, NON-WOOD MATERIAL.
